# **VISIBLE EMISSION OBSERVATION FORM**

Method Used <b>Method 9</b>		
Equipment Owner <b>N/A</b>		
Facility Name <b>McWane Ductile</b>		
EO Street Address		
EO City <b>N/A</b>	EO State <b>NA</b>	EO Zip <b>N/A</b>

Describe Emission Point <b>Fugitive VEs exiting under roof of Shrou</b>			
Height of Emiss. Pt. Start <b>24.87</b> End <b>Same</b>		Height of Emiss. Pt. Rel. to Observer Start <b>20.87</b> End <b>Same</b>	
Distance to Emiss. Pt. Start <b>215.18</b> End <b>Same</b>		Direction to Emiss. Pt. (Degrees) Start <b>241.83</b> End <b>Same</b>

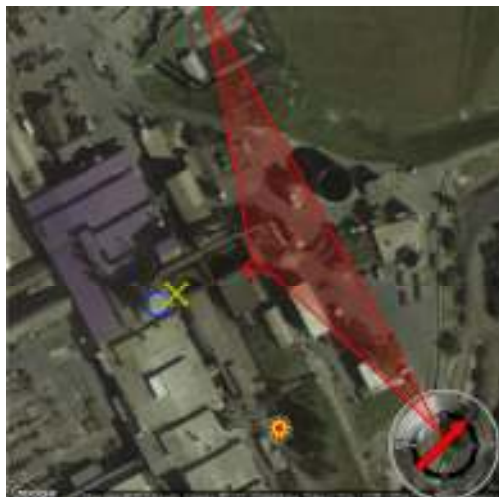
Describe Emissions VES due to charging of Start furnace in shroud End <b>Same</b>	
Emission Color Start <b>Dust</b> End <b>Same</b>	Water Droplet Plume Attached: ( ) Detached: ( ) N/A: ( X )

Notes Photos are of fugitive visible emissions exiting under the shroud
--
